Montana Department of Natural Resources and Conservation
State Water Projects Bureau

Project Information Report

December 2008

Future Priorities for Rehabilitation - Estimates of Costs for Water Users and DNRC

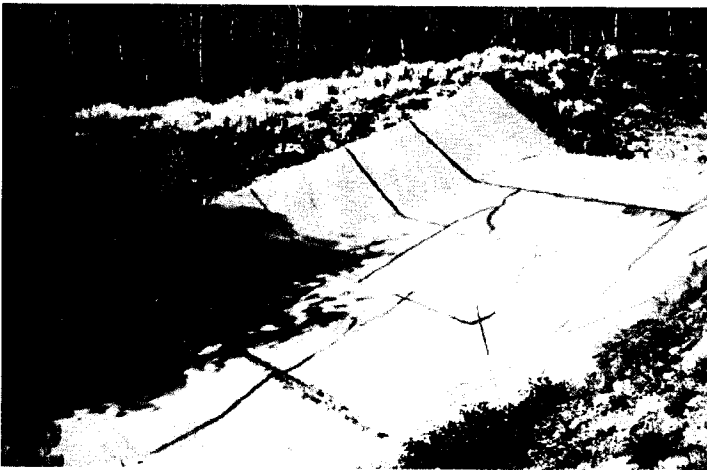
Concrete drop structure in spillway

- ◆ Construction of new spillway and channel that meets current standards.
- ◆ Installation of a new seepage collection and drain system.

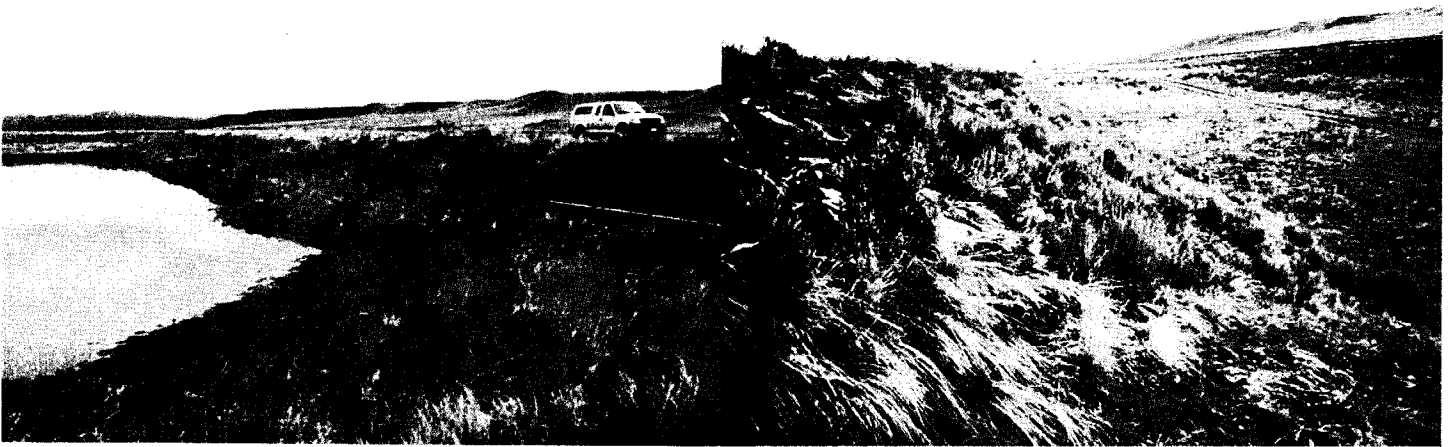
- ◆ Existing drains and outlet conduit are deteriorating and at the end of design life.
- ◆ Spillway is undersized and does not meet current safety standards.

- ◆ Replace the spillway or increase freeboard to meet current spillway standards.
- ◆ Construct an auxiliary spillway
- ◆ Replacing the outlet conduit with a new structure.
- ◆ Install new drains for seepage control.

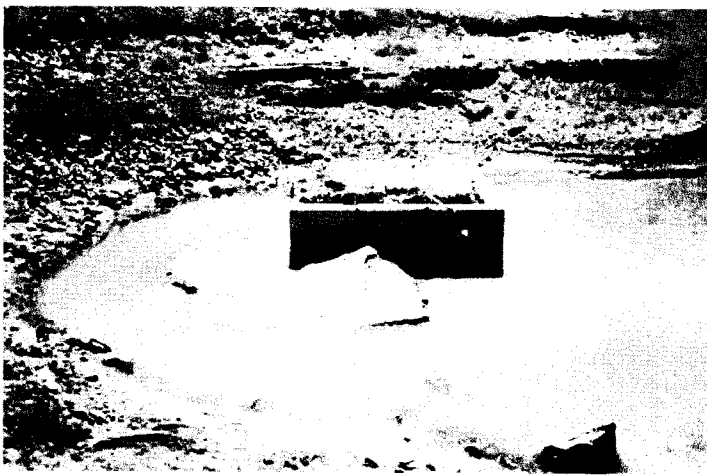
Inlet plugged with sediments

- ◆ Remove the old outlet structure, extend the conduit, and install a drainage system along side the new conduit extension
- ◆ Build a new energy dissipating outlet
- ◆ Construct a 15 foot high toe berm with a filter blanket drain

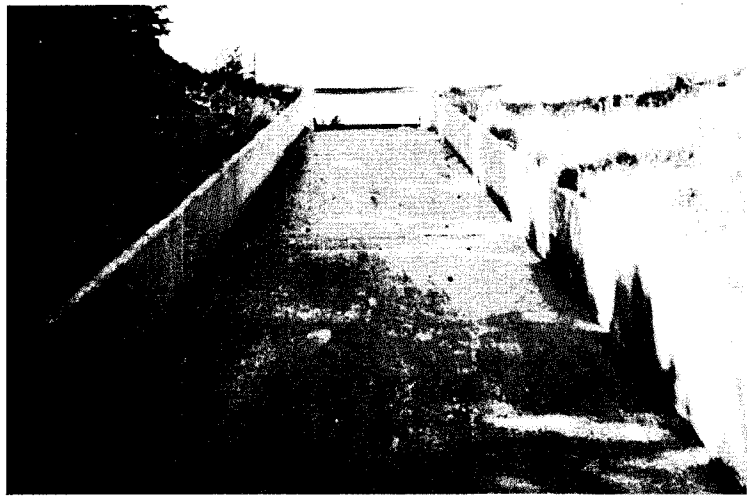
Spillway

- ◆ The spillway is nearing the end of its design life and will require future replacement. Replacement is needed due to concrete deterioration from age.
- ◆ Current safety standards may require a substantial increase in spillway capacity.
- ◆ The concrete outlet is deteriorating and needs repair. Lining or replacing the outlet are anticipated to be the primary options to correct the deficiencies.

- ◆ Construct a new spillway that meets or exceeds current safety standards.
- ◆ Line the existing outlet or replace with a new structure.

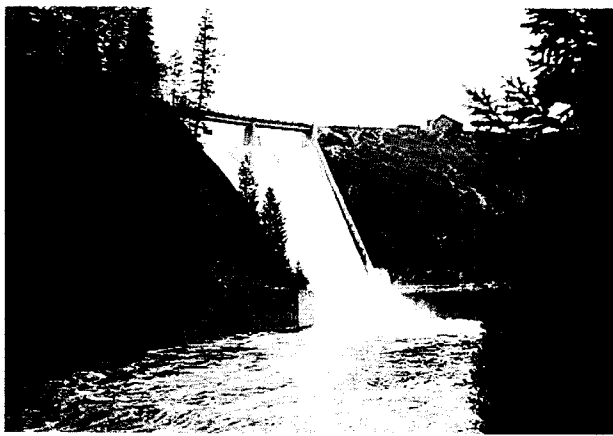
Spillway

- The spillway stilling basin floor is severely eroded.
- The spillway chute concrete is deteriorated and needs repairs or replacement.
- The spillway configuration has undesirable flow characteristics that reduce its safe capacity.

Est. cost for rehabilitation includes \$5 million for gates, \$8 million for the spillway, and \$750,000 for the stilling basin.

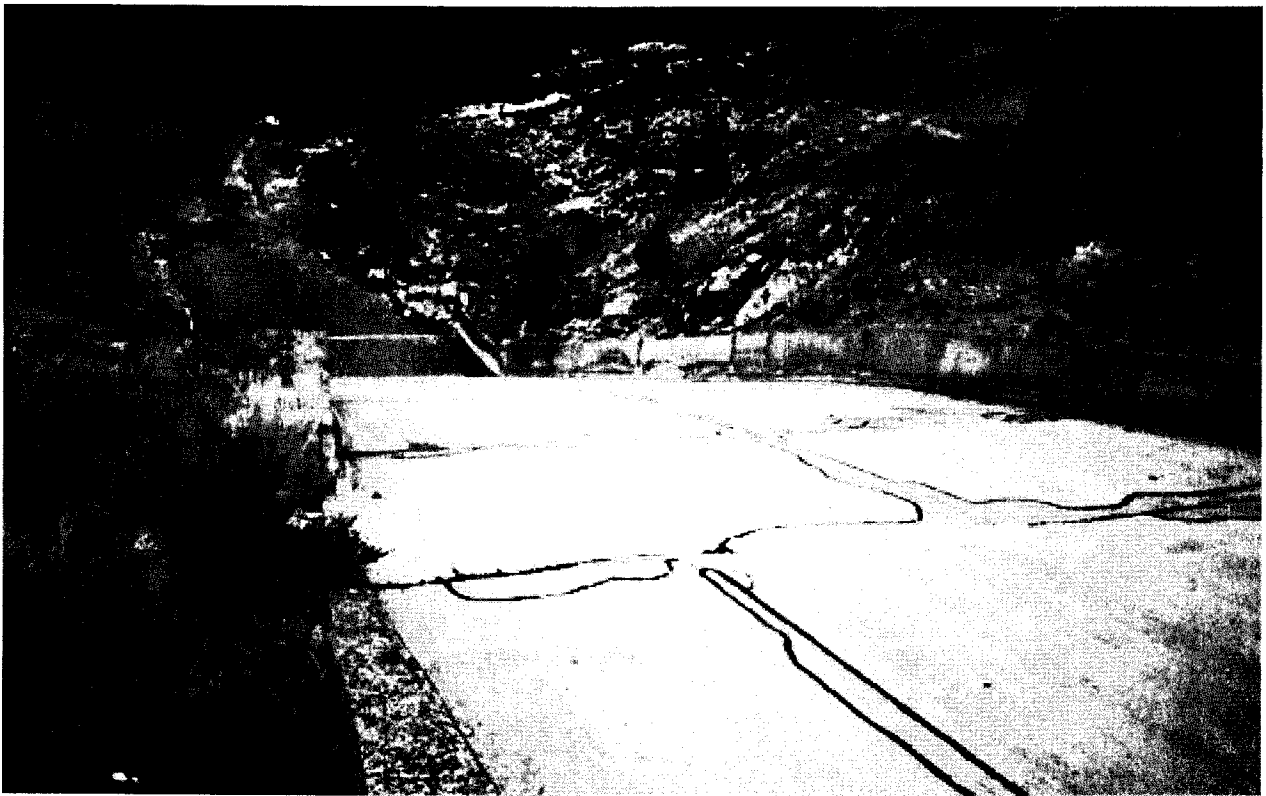
Ruby Dam Spillway

- Severe concrete deterioration exists in the spillway floor and walls. Spillway replacement is needed to correct the deficiencies.
- Excessive seepage may threaten the structural integrity of the spillway.

- A feasibility study to evaluate the problems at Ruby Dam at Ruby Dam was completed in 2007 by HLM Engineering of Billings . The \$285,000 feasibility study cost was authorized by the 2006 Legislature and paid by the DNRC.
- This project is in need of major rehabilitation. The preferred alternative identified in the feasibility study for rehabilitation, which includes a new spillway, outlet conduit, drains, access road and additional storage that could be marketed for beneficial uses, will bring the dam into full compliance with current safety and design standards and greatly reduce the state's liability.
- The proposed rehabilitation will also allow for future hydropower development.

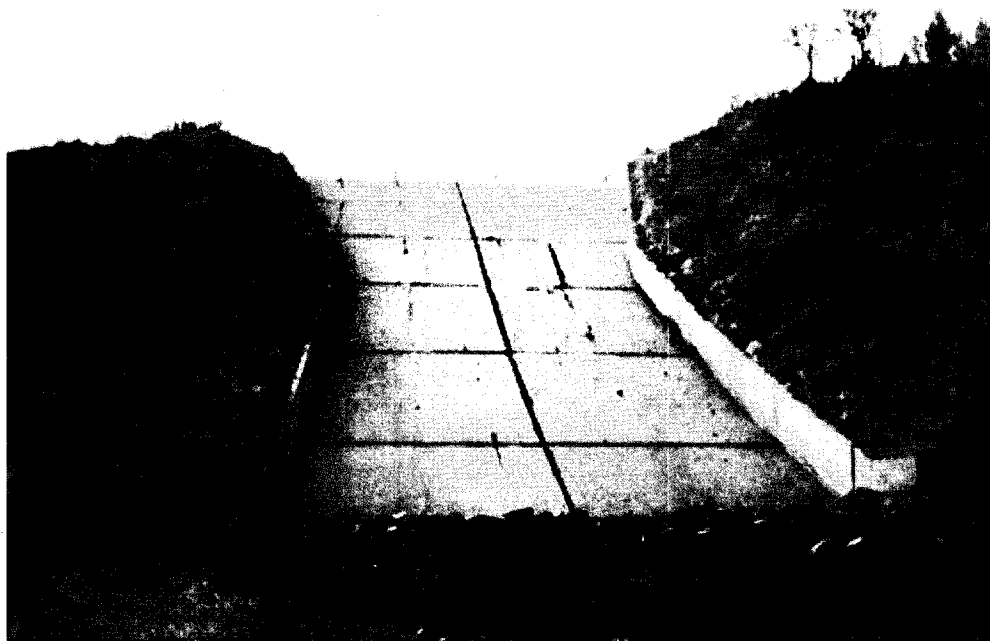
Spillway

- The spillway does not meet current safety standards and is not capable of passing the design flood event. The outlet conduit also needs to be assessed for deficiencies. Age related concrete deterioration exists in the spillway wall, floors, and outlet conduit.

- Replace the spillway with a new structure that meets current safety design standards.
- Install a new outlet conduit.
